Crawl Space Characterization [2005]

| Characterizing Crawl Spaces as Sources

of Mold in the Home Environment |

PREPARED BY ADVANCED ENERGY

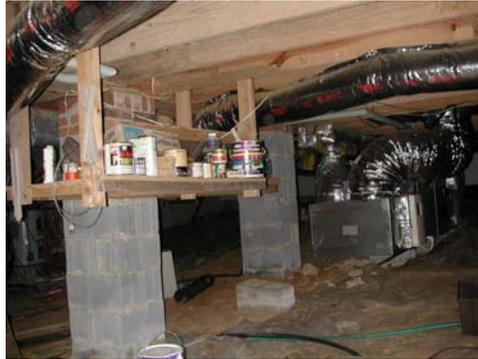
FIGURE 7 Gas and paint containers stored in the crawl space can release fumes that can travel through holes in the floor and ducts into livable parts of the house

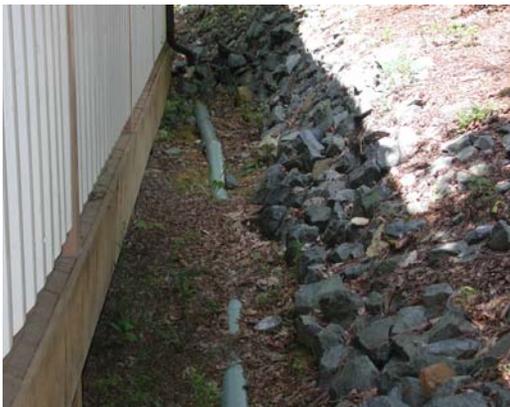
FIGURE 9 The slope of this yard into the front of the house could allow liquid water to run towards the house and its foundation.

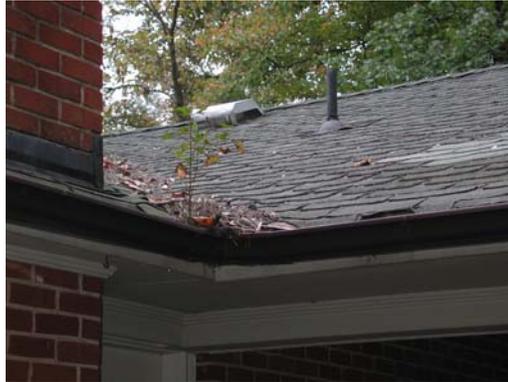
FIGURE 11 Clogged gutters and downspouts can inhibit free flow of water away from the house.

Seventy-seven percent of the houses had both gutters and downspouts. This total does not indicate adequate installation of each feature, simply that both are present. Of the homes with gutters, 30 percent were observed to have gutter clogging or spillover at the time of the visit (see Figure 11).

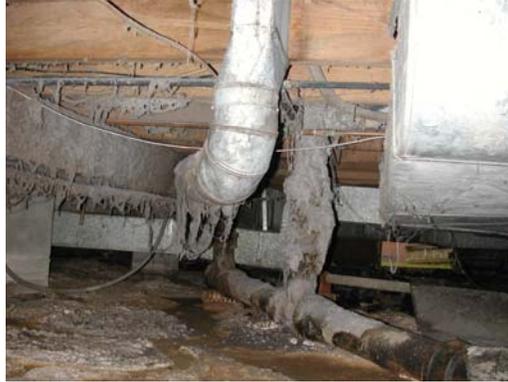
FIGURE 12 This dryer was not vented to the outside and introduced lint and moisture into the crawl space.

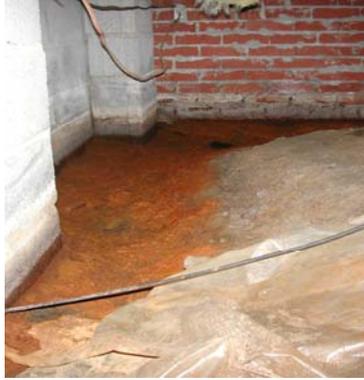
FIGURE 15 Dark-staining in the crawl space is an indicator of long-term wetness.

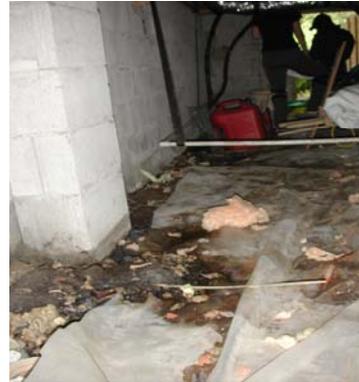
FIGURE 16 Significant amount of water pooling along perimeter of crawl space wall

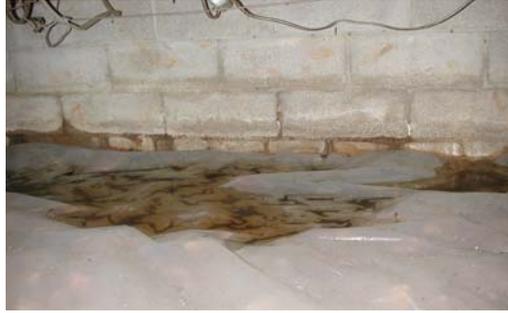
FIGURE 23 Due to bulk water infiltration or significant dripping from condensation, water can pool on the surface of the ground vapor retarder

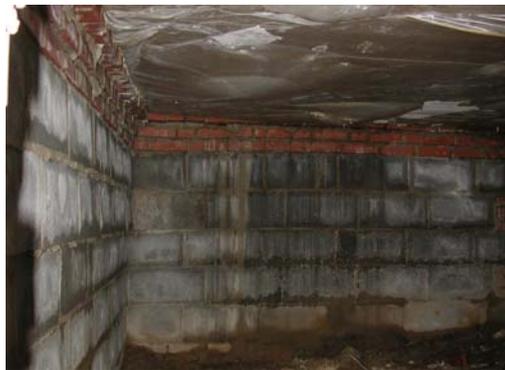
FIGURE 24 Through capillary action liquid water is absorbed into the masonry and migrates to the surface, creating discoloration

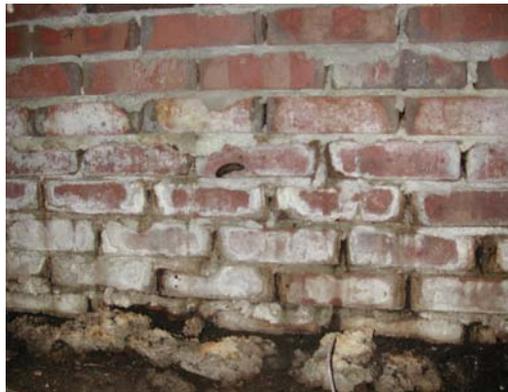
- **Efflorescent salts.** Forty-four percent (19) of the crawl spaces studied had signs of efflorescent salts leaching through the walls. Of these 19 crawl spaces, seven were sampled during the humid season. Of those with efflorescence, 10 exhibited minimal evidence, four some evidence and five were not classified. Figure 26 shows efflorescent salts leaching through the foundation wall.

FIGURE 26 When water evaporates it leaves behind the efflorescent minerals that show up as whitish coloring on foundation blocks

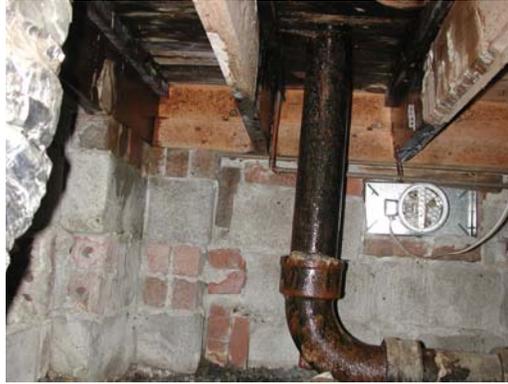
- **Condensation.** Thirty-three percent of the houses showed condensation on duct or pipe surfaces. Twelve of the 15 houses with condensation present were sampled during the humid season.
- **Waterlogged ducts.** Sixteen percent of the houses exhibited waterlogged ducts. Of these seven homes, five were sampled in the humid season.
- **Plumbing leaks.** Thirty-one percent of the houses were found to have plumbing leaks at time of the visit. Figure 27 illustrates the problem plumbing leaks could cause on wood surfaces.

FIGURE 27 A plumbing leak led to saturated and rotting wood framing and sub floor

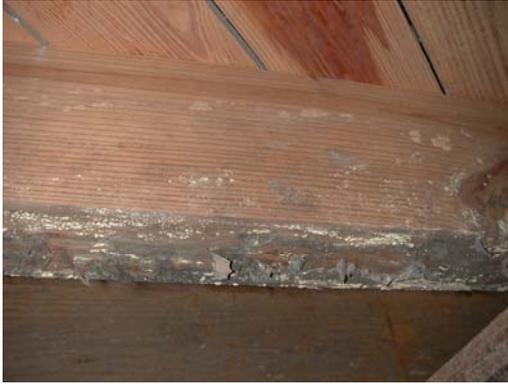
- **Visible mold (fungi).** Figure 28 illustrates the percentage of houses noted to have visible mold. The determination of presence of mold was by visual inspection only. Fungal spore counts conducted by Duke University can be found below in the Bioaerosols – fungal spores section. Of the 62 percent (28) of houses with visible mold noted, 10 had minimal amounts of mold, seven had some amounts of mold, two had significant amounts of mold and nine were not classified. Twelve of 28 houses with mold were sampled during the humid season; 19 had mold located in the center of the crawl space. Of the crawl spaces that had visible mold in only one location, 79 percent recorded that location as the center of the crawl space. Figures 29 and 30 show growth on a floor joist.

FIGURE 29 Visible mold growth on floor framing

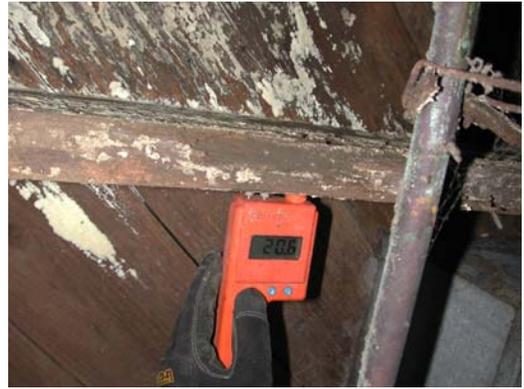
FIGURE 30 The wood moisture meter reading of 20.6 is at mold-forming levels and could explain the growth on the wood framing

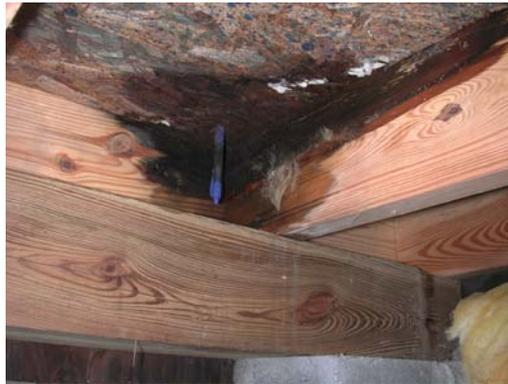
- **Wood rot.** Figures 31 and 32 illustrate crawl spaces with wood rot. Figure 33 shows the percentage of crawl spaces that have visible wood rot inside the crawl space. Twenty-two percent had wood rot external to the crawl space.
 - The county breakdown of crawl space wood rot was as follows: seven in Durham, 10 in New Hanover, none in Wayne and four in Wilson.

FIGURE 31 A pen is able to penetrate the rotted sub floor

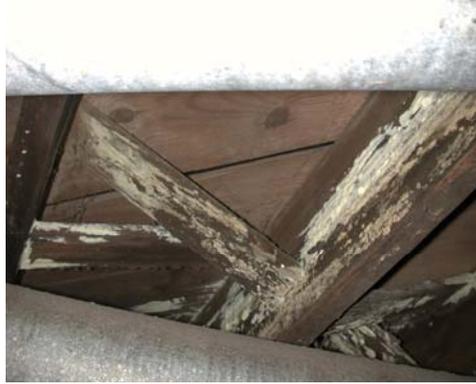
FIGURE 32 The rot illustrated in this picture could have resulted from a condensation event

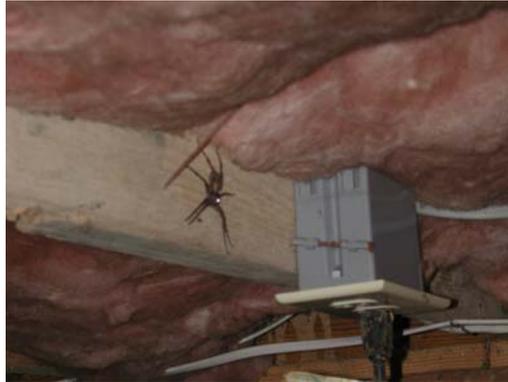
- **Termite tunnels.** Two of the crawl spaces were found to have termite tunnels.
- **Animals and insects.** Thirty-six percent of crawl spaces were found to have evidence or sightings of animals. Most frequently seen were insects (crickets, roaches, other) and frogs, and evidence of rats, cats, a bird and a snake. Figure 34 displays a spider found in a crawl space.

FIGURE 34 Bugs were commonly seen in crawl spaces. Camel crickets were the most frequently found.

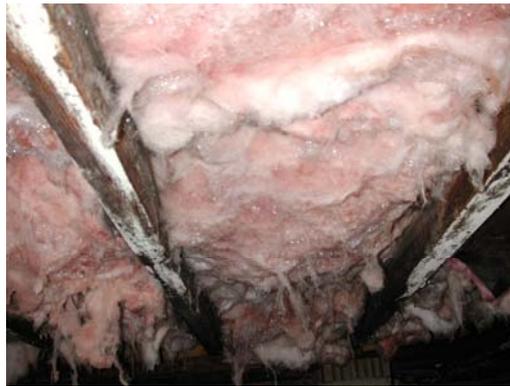
FIGURE 38 Floor joists, surrounded by wet insulation, display fungal growth on the wood framing.

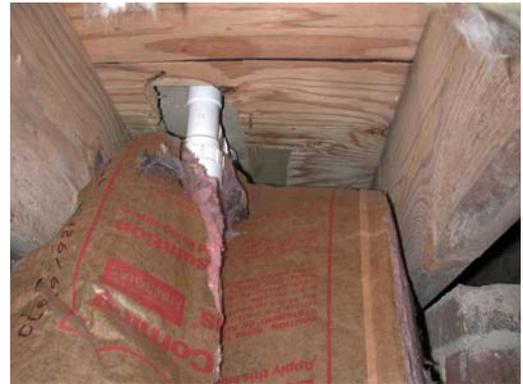
FIGURE 39 Fallen insulation reveals a floor penetration.

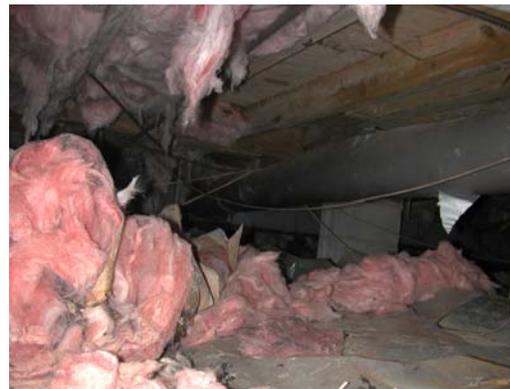
FIGURE 40 Fallen insulation found on crawl space floor.

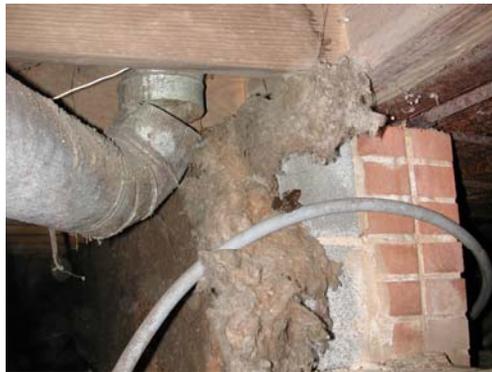
FIGURE 43 A broken supply leads to duct leakage, introducing crawl space air into the livable parts of the house.
